STEEL INSTITUTE OF RWTH AACHEN  
UNIVERSITY

**INTERNATIONAL MASTER PROGRAM  
IN RENEWABLE ENERGY AND GREEN HYDROGEN  
SPECIALITY: GREEN HYDROGEN PRODUCTION AND  
TECHNOLOGY TRACT  
MASTER THESIS**

**Microstructural Characterization and Study of Hydrogen  
Embrittlement in Duplex Stainless Steels**

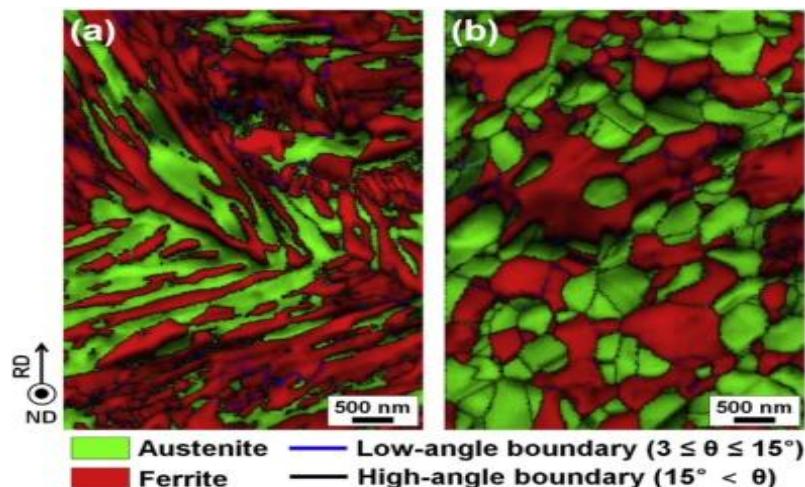
Figure 1.1: Optical observation of DSS after metallographic preparation:

(a) the hot-rolled and annealed (HRA) specimen and (b) the cold-rolled and annealed (CRA) specimen (Han *et al.*, 2017).

Figure 1.1, the microstructure of both a hot-rolled and annealed (HRA) sample and a cold-rolled and annealed (CRA) sample are shown. The green and red colour corresponds to the austenite and ferrite phases respectively, while the blue and black lines demonstrates low angle and high angle boundaries (Han *et al.*, 2017).

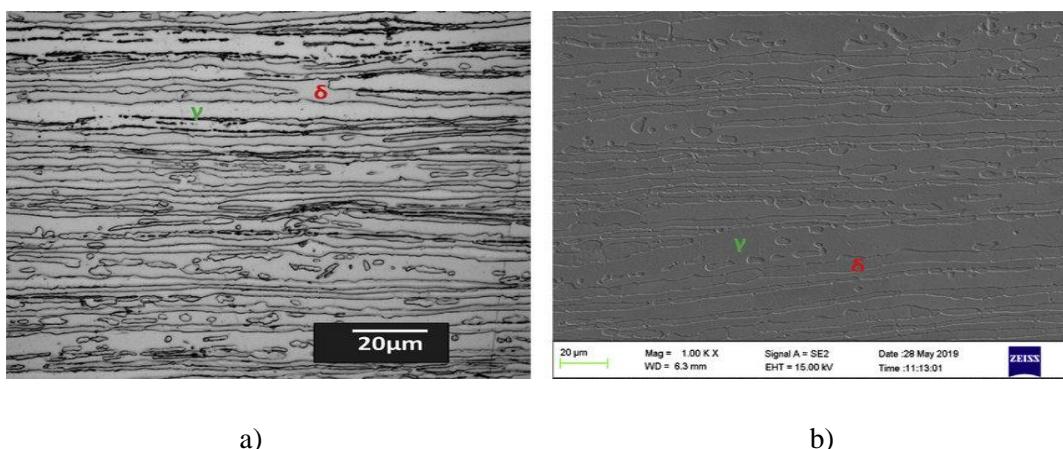
Figure 1.2: (a) an Optical Micrograph (b) a Scanning Electron micrograph of the as received hot rolled DSS, showing austenite and ferrite phase (Olanipekun *et al.*, 2019).

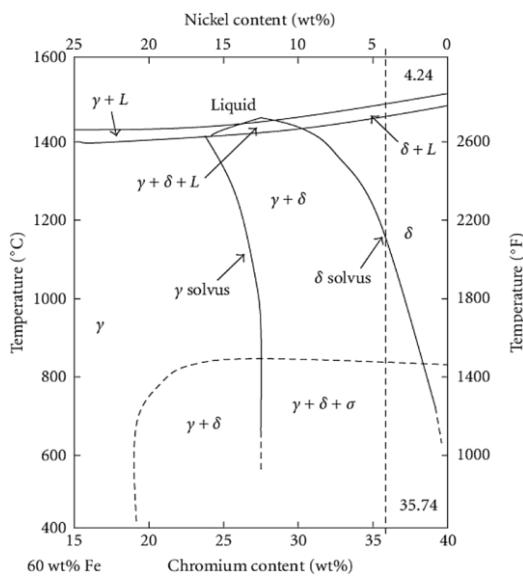
Figure 1.3: Phase diagram of duplex steel (Liao and Chumbley, 2019)

Figure 1.3 is showing the phase diagram of duplex stainless steels (DSS) involves a distinct transformation from fully liquid metal to a dual-phase solid microstructure of ferrite and austenite. This process is governed by the alloy composition, thermodynamic phase equilibrium.

A typical solidification of DSS begins with the nucleation of ferrite from the liquid phase at the liquidus temperature. As cooling continues, austenite precipitates from ferrite through a solid-state transformation. The final microstructure consists of a near equal distribution of ferrite and austenite phases.

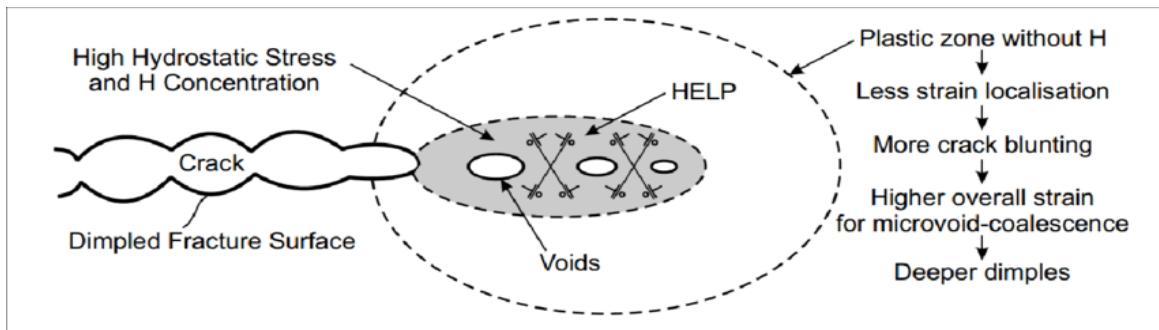
Figure 1.4: The diagrammatic representation of the HELP mechanism: the presence of hydrogen encourages dislocation mobility and localises plastic deformation at the crack tip; the microcavities in this area of high hydrogen concentration and hydrostatic stress coalesce to cause the crack to propagate (Tomoki, 2019).

- a. **Hydrogen-enhanced localised plasticity (HELP):** According to (Lynch, 2011), hydrogen-assisted cracking (HAC) happened as a result of the solute hydrogen promoting dislocation movement. It was suggested that deformation was confined around fracture points as a result of solute hydrogen aiding dislocation activity, as hydrogen concentrations were localized near crack tips due to hydrostatic forces or hydrogen entrance at crack tips. It was then suggested that a more localised microvoid-coalescence (MVC) process than what would happen in inert conditions could thus cause sub-critical crack propagation. As seen in Figure 1.4, they postulated that fracture propagation happens via the coalescence of microcavities in the region of high hydrostatic stress and hydrogen concentration, which is far more localised than in an inert environment.

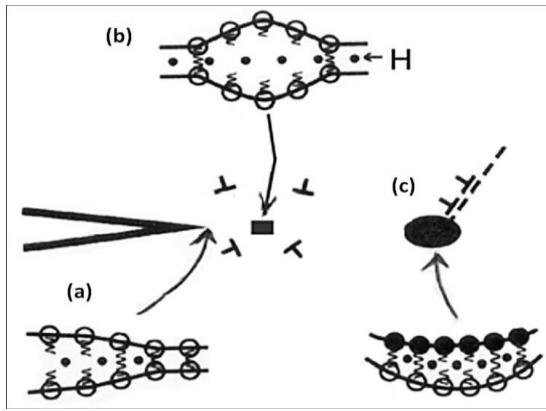
Figure 1.5: The diagrammatic representation of potential HEDE-producing zones (a) near the tip of the Crack; (b) a few tens of nanometres distant from the tip and (c) at grain to grain or precipitate to precipitate interfaces (Tomoki, 2019).

According to the Figure 1.5, showing the potential areas where the HEDE might appear; (a) near the crack tip where a high concentration of hydrogen is caused by plastic deformation and high hydrostatic stress; (b) a few tens of nanometres away from the crack tip where the dislocations' barrier effect results in a maximum hydrostatic stress; and (c) at grain-to-grain or precipitate interfaces up to several micrometres away from the crack tips.

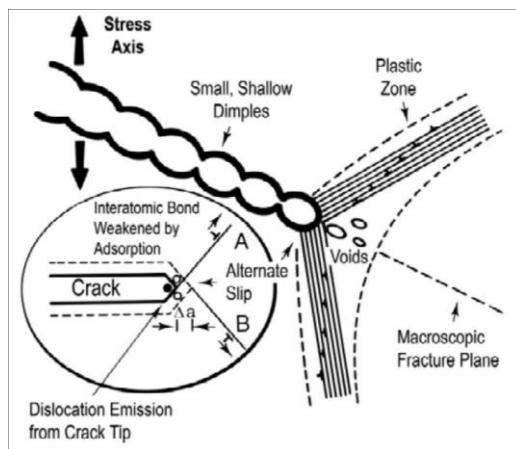
Figure 1.6: The AIDE mechanism is shown schematically. The two stages of embrittlement are the nucleation and growth of microcavities ahead of the crack tip and the local reduction of the material's cohesion energy, which encourages the nucleation and the emission of dislocations from the crack tip (Dwivedi and Vishwakarma, (2018)).

**c. Adsorption-induced dislocation Emission AIDE:** According to (Dwivedi and Vishwakarma, (2018)), which explains that this mechanism is essentially a hybrid of HEDE and HELP. This mechanism involves the surface adsorption of solute hydrogen atoms at the area of concentrated stress, such as fracture tips. Hydrogen adsorption at the crack tip causes the HEDE mechanism to degrade and the material's cohesive strength or interatomic link, while the HELP mechanism facilitates dislocation injection from the crack tip, which leads to fracture propagation via slip and microvoid formation. Decohesion and dislocation emission at the crack tip have caused the fracture to nucleate and expand in this way. This happens because of the combined effects of MVC and slide at the crack tip, cracks grew and fractured concurrently. High levels of adsorbed hydrogen on the surface of Fe, Ni, and Ti have been found to support the AIDE process. As shown in Figure 1.6.

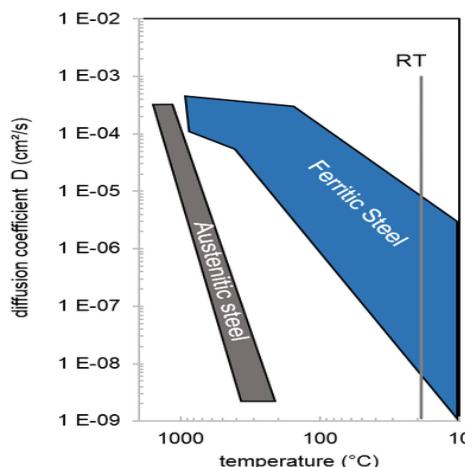
Figure 1.7: Hydrogen diffusion coefficient in ferrite and austenite depending on the temperature. (Klett and T. Hassel, 2020)

According to Figure 1.7, in comparison to ferritic steel, austenitic materials are far more capable of solving hydrogen. In addition, compared to ferrite, the rate of hydrogen diffusion in austenitic iron is much lower.

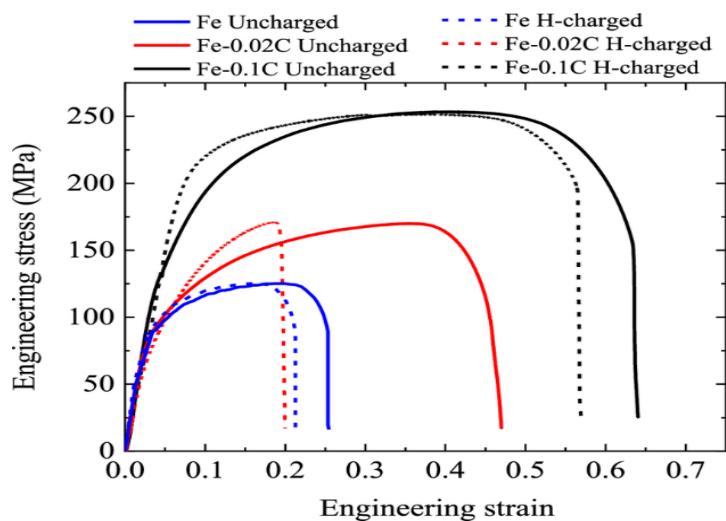
Figure 1.8: Changes in engineering stress-strain curve with and without in-situ electrochemical hydrogen charging at the strain rate of  $3.4 \times 10^{-6}\text{s}^{-1}$ . Source: (Pichler *et al.*, 2023)

SSRT assesses DSS that is sensitive to hydrogen embrittlement by mechanical loading in uniaxial stress of specimens at a strain rate of  $10^{-6}$  to  $10^{-7}\text{s}^{-1}$  in both air and hydrogen environments. Fracture behavior, reduced ductility, and brittle modes signal embrittlement (Francis and Byrne, 2021). Engineering stress-strain curves for Fe, Fe-0.02C, and Fe-0.1C materials with and without in-situ hydrogen charging are displayed in Figure 1.8.

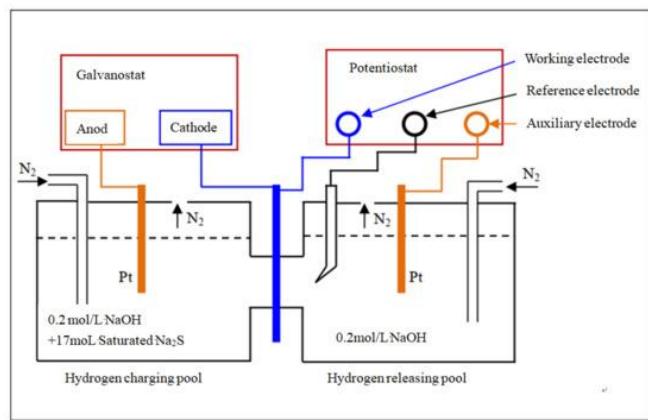
Figure 1.9: Schematic diagram of hydrogen permeation test device. (Li *et al.*, 2023).

According to the Figure 1.9, a 1mm thick sample was positioned between the hydrogen charging and hydrogen releasing cells during hydrogen permeation, and the sample and solution had a  $7.065\text{cm}^2$  (30mm in diameter) contact area on both sides.

The anode side of the sample, which releases hydrogen, was nickel-free. To eliminate oxygen, nitrogen was continually added to both electrolytic cells. To keep the steel substrate from oxidising, the anode side was coated with nickel. The potentiostat's settings were adjusted to place the sample at potentiostatic polarisation with a steady potential of 250 mV.

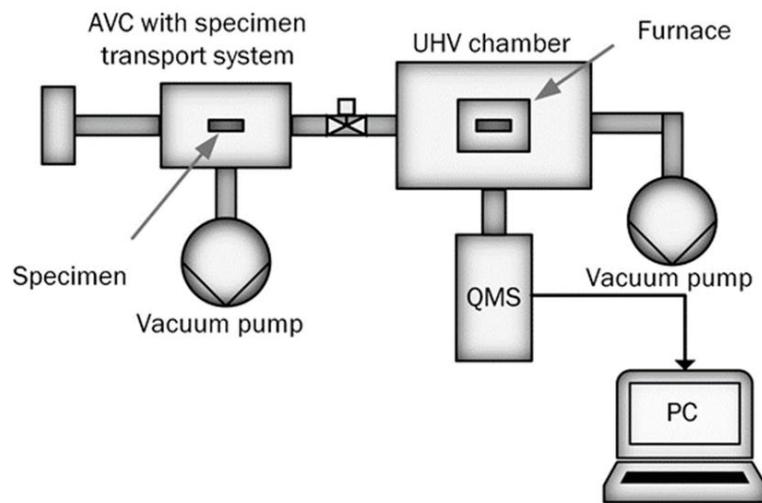
Figure 1.10: Schematic diagram of Thermal Desorption Analysis (Fangnon et al., 2020).

The Figure 1.10 shows the TDA schematic diagram, its exceptional sensitivity and ability to quantify the little amount of desorbed hydrogen more precisely than other methods make it special.

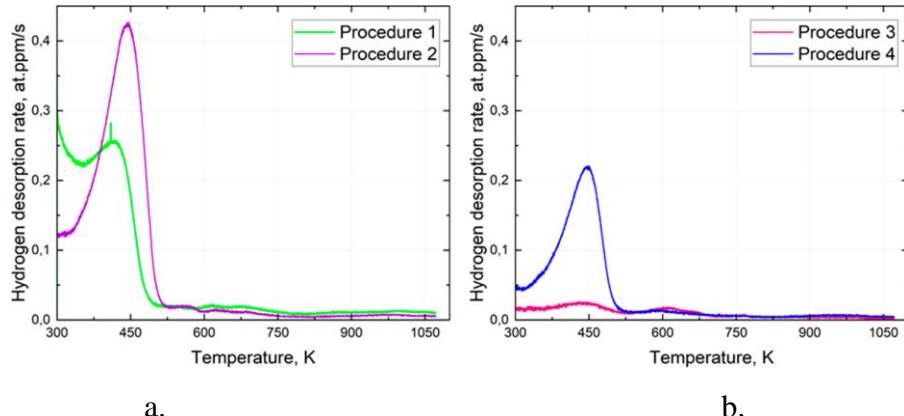
Figure 1.11: TDA curves corresponding to measurement procedures 1,2, with the same AVC dwelling time which is 15 minutes (a) and Procedure 3, 4, with the same AVC dwelling time which is 60 mins on (b) (Fangnon *et al.*, 2020).

High HE detention and a deeper comprehension of the HE process can be obtained by combining the TDA approach with additional tests (Dwivedi and Vishwakarma, (2018)). Figure 1.11 shows the TDA curves corresponding to measurement procedures.

The hydrogen TDA analysis was used to examine the hydrogen redistribution in the steel. During the approximate 15 minutes absolute vacuum conditions (AVC) residence period, there was a notable hydrogen redistribution within the sample material, as seen by the rediffusion signal (RDS) data obtained using measuring techniques 1 and 2. The AVC refers to the vacuum system where the sample is kept under absolute value conditions before heating begins. This is to allow hydrogen inside the steel to distribute before the actual desorption measurement starts. The RDS captures the redistribution of hydrogen within the material from that AVC residence time.

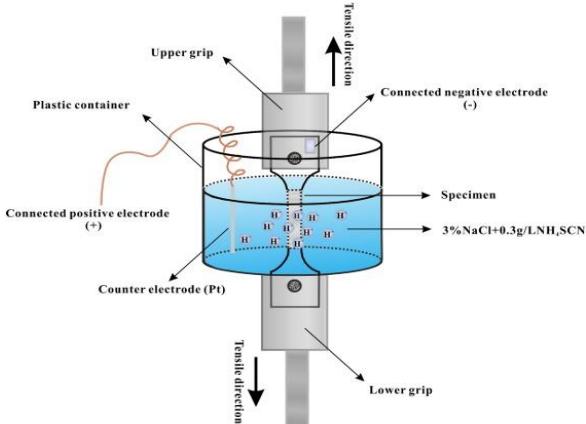
Figure 1.12: In-situ SSRT schematic showing loading and Hydrogen charging system. Source: (Fu et al., 2020)

According to Figure 1.12: In-situ SSRT schematic showing loading and Hydrogen charging system. Source: (Fu et al., 2020), the specimen served as the cathode and the platinum sheet as the anode during in-situ hydrogen charging.

In contrast to hydrogen pre-charging, which is more representative of the actual service scenario, hydrogen could be efficiently delivered into the sample without generating surface defects since the hydrogen bubbles were equally deposited on the sample surface.

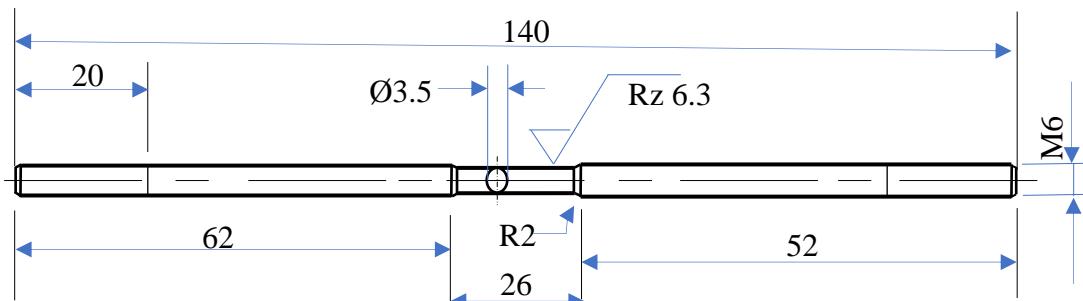
Figure 0.1: Dimension of the tensile test sample

The material under investigation was the duplex stainless steel S82441, which has a balanced dual-phase microstructure made up of austenite and ferrite. Samples for the research were prepared according to the standard metallurgical procedures which involve machining to dimension as seen in Figure 2.1, sectioning, grinding, polishing and cleaning to get rid of any surface impurities. The chemical composition of the material was taken from delivered data sheet of the supplier Swiss Steel Group, ensuring the accurate measurement of oxygen, hydrogen and other alloying elements. As seen in Figures 2.2 and 2.3, the preparation made sure that the specimens met ASTM E8/E8M requirements (BSSA, 2025) for tensile testing emphasizing the areas intended for hydrogen charging and protection.

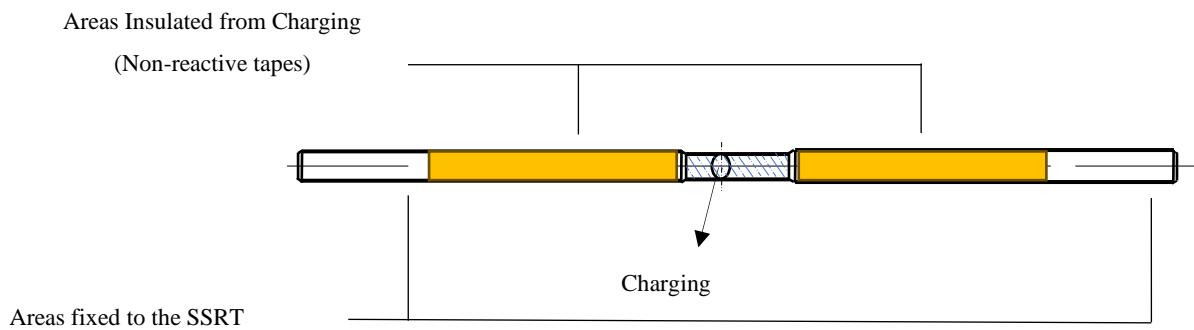
Figure 0.2: The tensile test sample, indicating the charging area

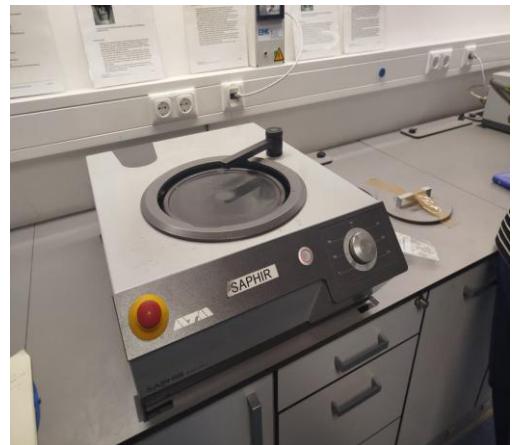
*Figure 0.5: The Saphir M1 Grinding and Polishing machine*

Using the Saphir M1 device, the grinding of the specimen begins, with a tap water used as a grinding medium, having set the speed to 300 rpm, the sample are ground on a P80 SiC (Silicon Carbide) paper which is the coarsest and gradually graduates to further grinding steps with P240, P320, P500, P800, P1200 and P2400 which is the finest paper we used to get the best result. The samples are always rotated at 90° between the individual sanding steps. After surface grinding, the samples are rinsed under running water and then cleaned in an ultrasonic bath in a beaker that is filled with ethanol for 1-2mins and dried under the dryer.

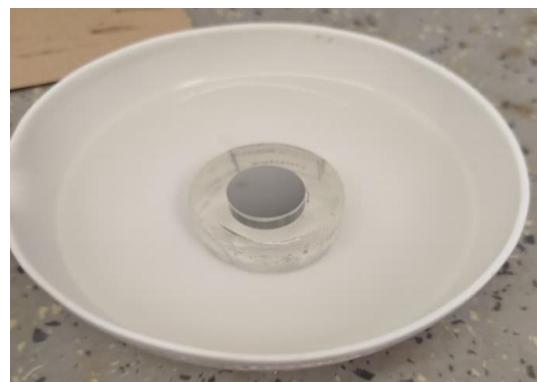
Figure 0.13: Etching procedure inside the solution

The etching procedure: The specimen was first polished, cleaned and then placed inside a solution of 1000ml of warm distilled water, 200 g of ammonium bifluoride and 5g of Potassium disulfide, for 3 minutes to allow visibility of boundaries and distribution of ferrite and austenite under Optical microscope or scanning electron microscope (SEM).

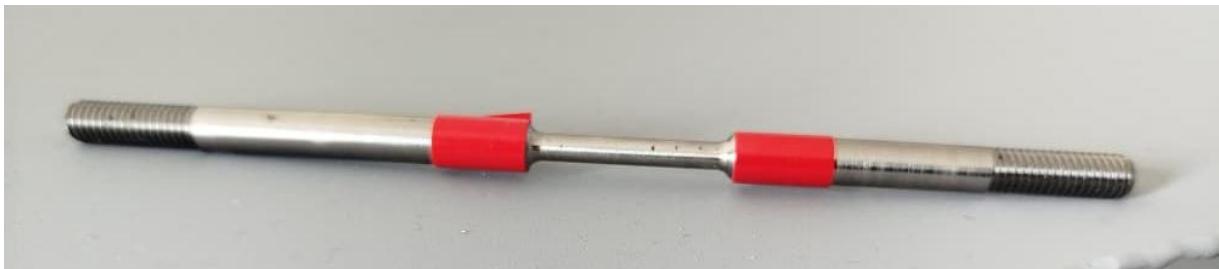
Figure 0.14: The test sample with the non-reactive insulating tapes

The manufactured tensile specimens were submerged in an acidic electrolyte solution containing 0.05M Sulphuric acid ( $H_2SO_4$ ) in order to perform electrochemical hydrogen charging. Each specimen serves as a working electrode during charging. In order to encourage the diffusion process of hydrogen into the material, a steady current density was provided. As shown in Figures 2.2 and 2.14, a non-reactive insulating tape were used to safeguard regions not meant for charging. For proper hydrogen intake optimisation and to simulate the circumstances that may cause embrittlement, the hydrogen charging was carried out right before the tensile test.

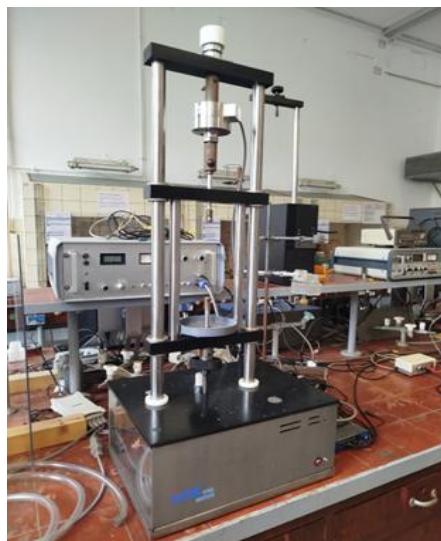
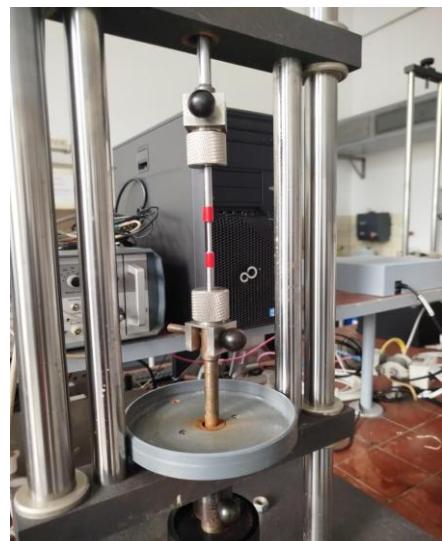
Figure 0.15: Material testing equipment (a) Before set-up (b) During SSRT setup

As shown in Figure 0.15 a and b, the material testing system was used to perform the slow strain Rate Test (SSRT). The tests were conducted in two distinct environments: the in-situ hydrogen charging and the ambient air at a regulated temperature of around 21°C. With a constant speed of 11mm per day,  $1.273 \times 10^{-4} mms^{-1}$  (per second), each specimen was subjected to a strain rate of  $5 \times 10^{-6} s^{-1}$  in order to assess its tensile characteristics and vulnerability to hydrogen embrittlement. Stress-strain curves, yield strength, ultimate tensile strength, elongation at break, and time to failure were among the data that recorded during the test. So as to be able to simulate real word exposure scenarios where mechanical loads and hydrogen infiltration happens simultaneously. The in-situ SSRT used simultaneous tensile loading and electrochemical hydrogen charging as seen in Figure 0.17 and Figure 0.18.

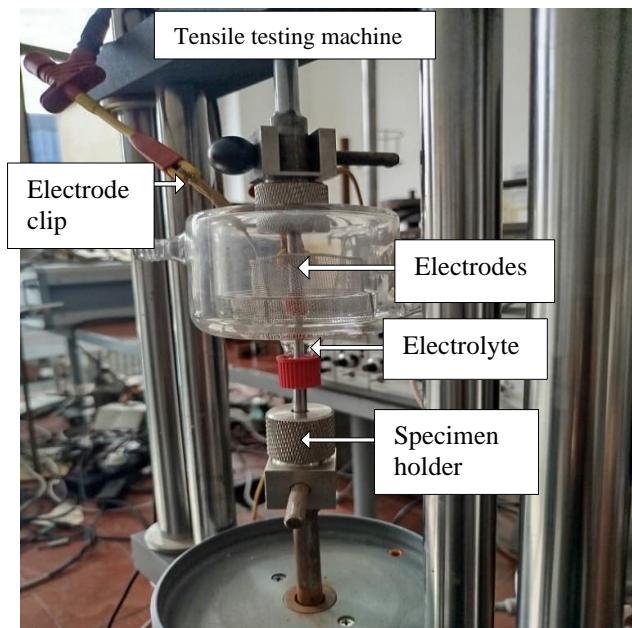
Figure 0.17: The In-situ SSRT Setup

According to Figure 0.17, the positive electrode is attached to the platinum while the negative terminal is attached to the sample. From the sulphuric acid solution, the hydrogen ion  $H^+$  goes to the sample which is negatively charged so that hydrogen can concentrate on the sample, this is done for practical purposes. At the top of the machine, is the force sensor as shown in Figure 0.18, which measures the Force being applied.

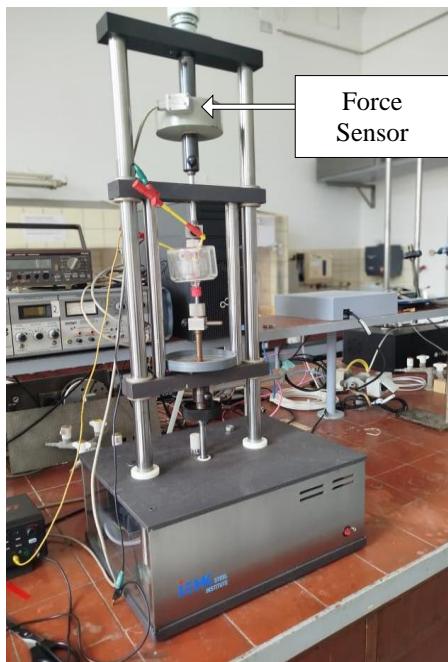
Figure 0.18: Complete *in-situ* SSRT setup

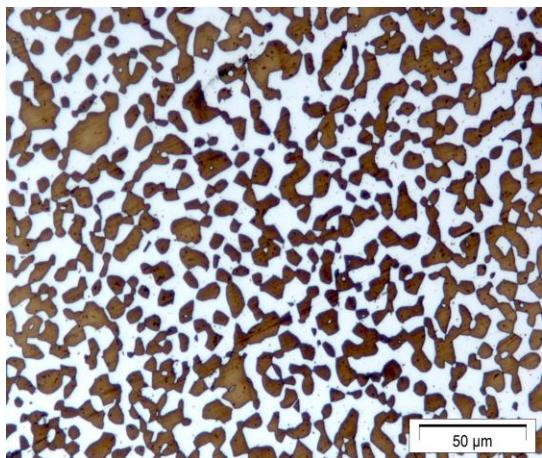
*Figure 0.1: Microstructural analysis at 500X magnification*

Using an Optical microscope, the microstructure of the material in as received condition is presented in Figures 3.1 and 3.2 after grounding, polishing and etching.

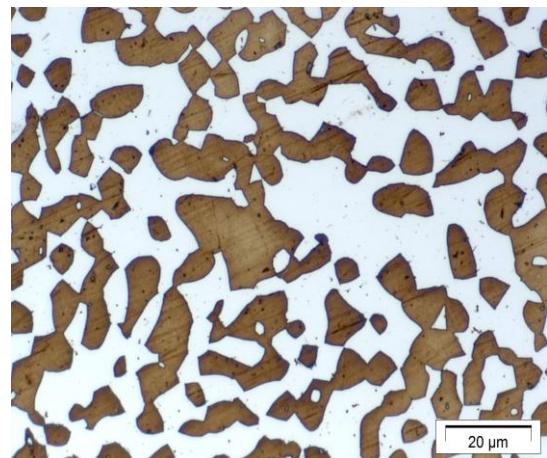
*Figure 0.2: Microstructural analysis at 1000X magnification*

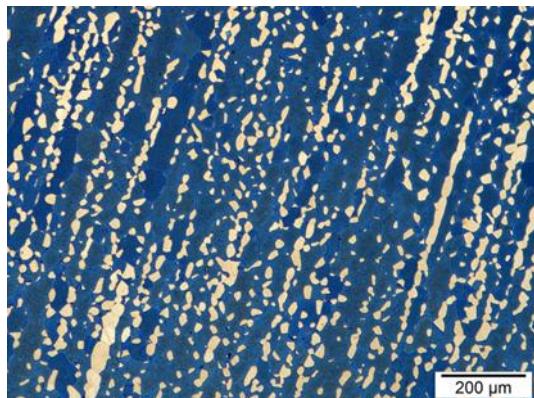
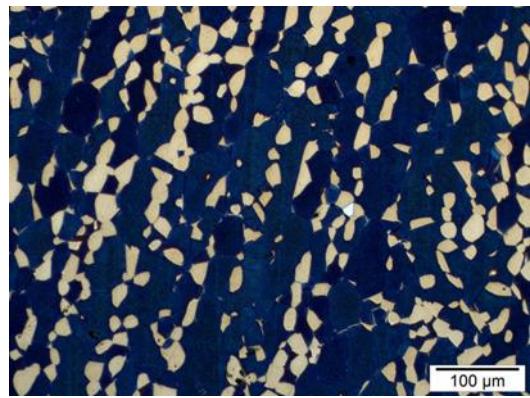
Figure 0.3: Microstructure at 1250 °C, 90 mins 100X magnification

Figure 3.3: Microstructure at 1250 °C, 90 mins 200X magnification

To change the austenite-ferrite volume fractions a heat treatment at 1250 °C for 90 minutes in a muffle furnace is applied. The microstructure is shown in Figures 3.3, showing ferrite (light phase) and austenite (dark phase). Austenite appeared as small patches scattered throughout the ferrite background.

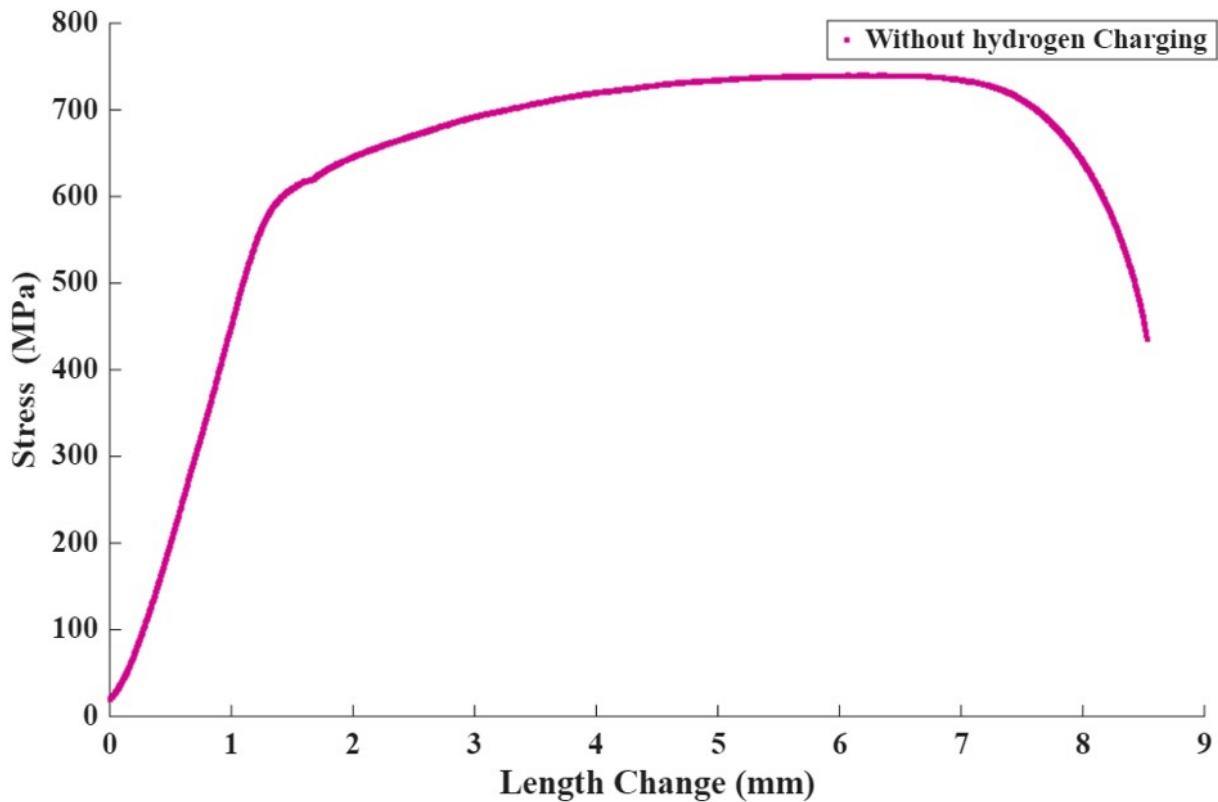
Figure 0.4: Stress-length change curve of DSS in-Air

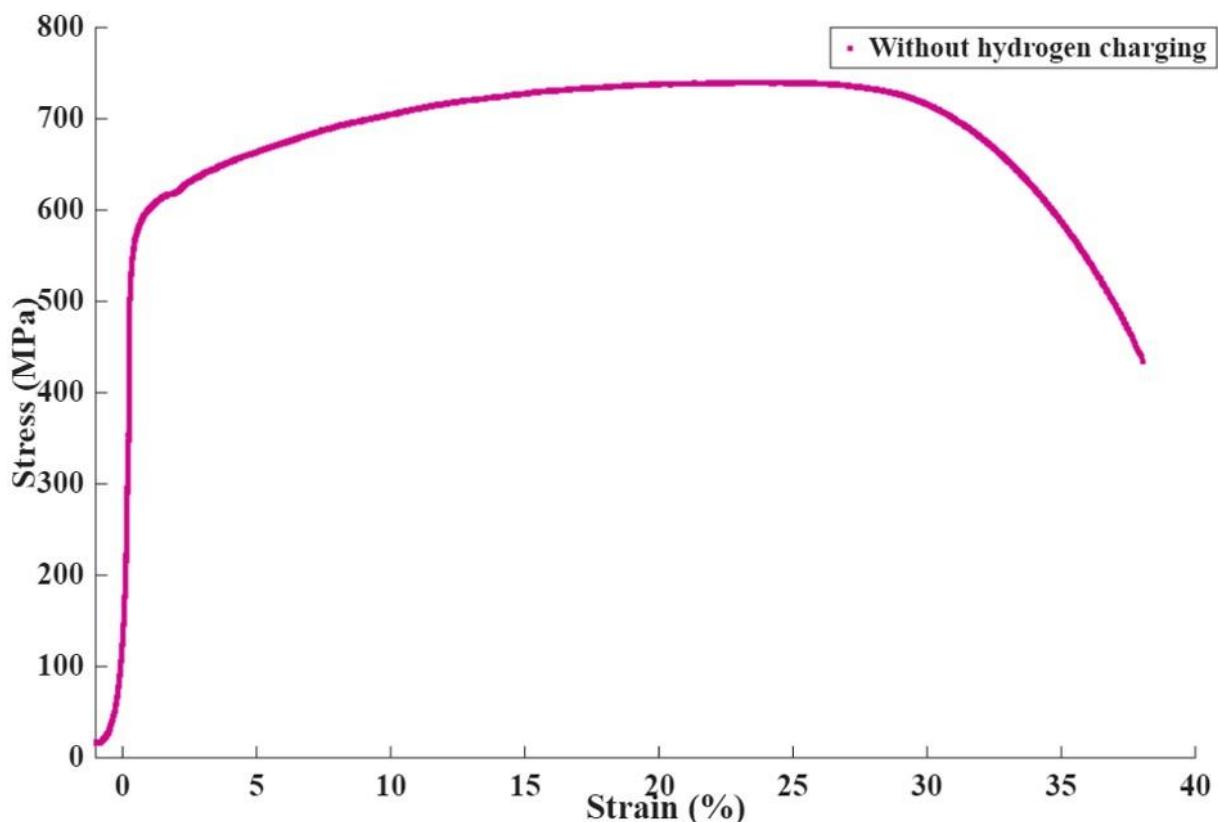
Figure 0.5: Stress-strain curve of DSS in-Air

The above curve indicates a tensile behaviour of the duplex stainless steel tested in-air, that is,

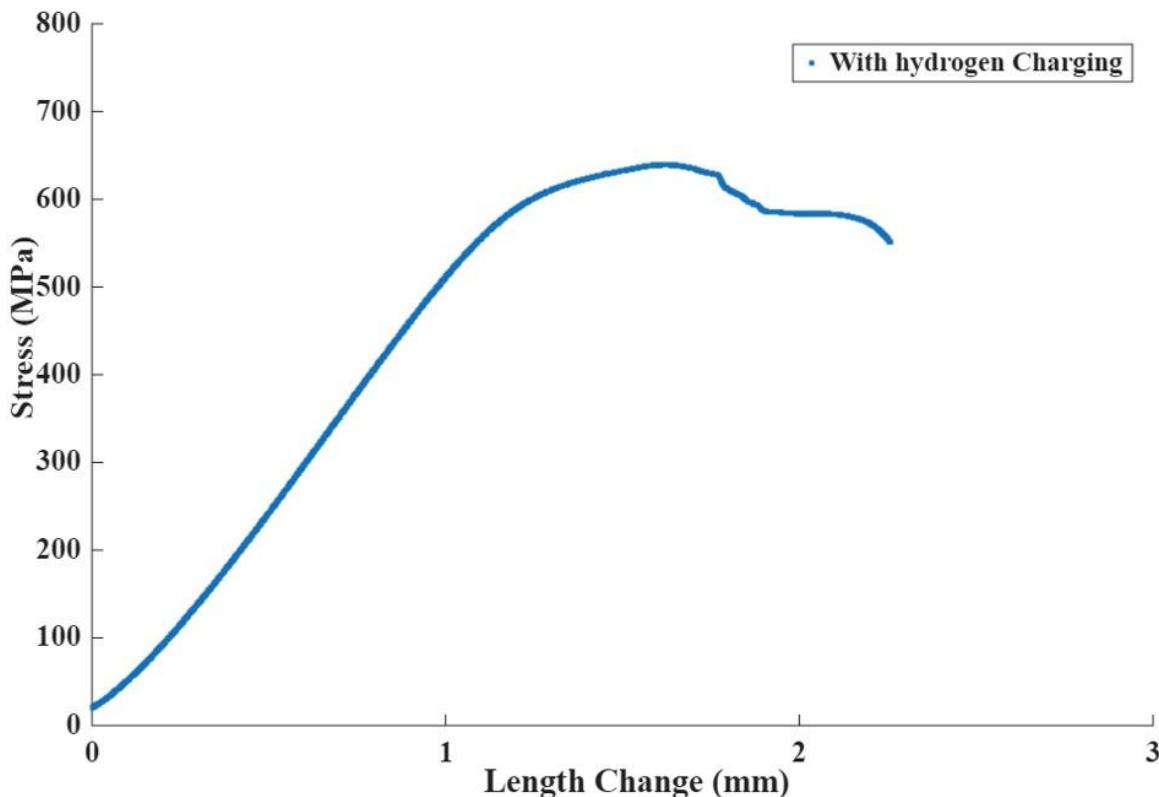
Figure 0.6: Stress-length change curve under hydrogen charging

The in-situ SSRT system combined tensile testing with electrochemical hydrogen charging using a 0.05M sulphuric acid ( $H_2SO_4$ ) solution. A platinum electrode and the sample served as the working electrode was adopted to maintain current density, thereby promoting hydrogen absorption. Figures 3.6 and 3.7 are showing the SSRT results with hydrogen charging. Hydrogen charging significantly reduced elongation and time to failure with brittle fracture behaviour observed.

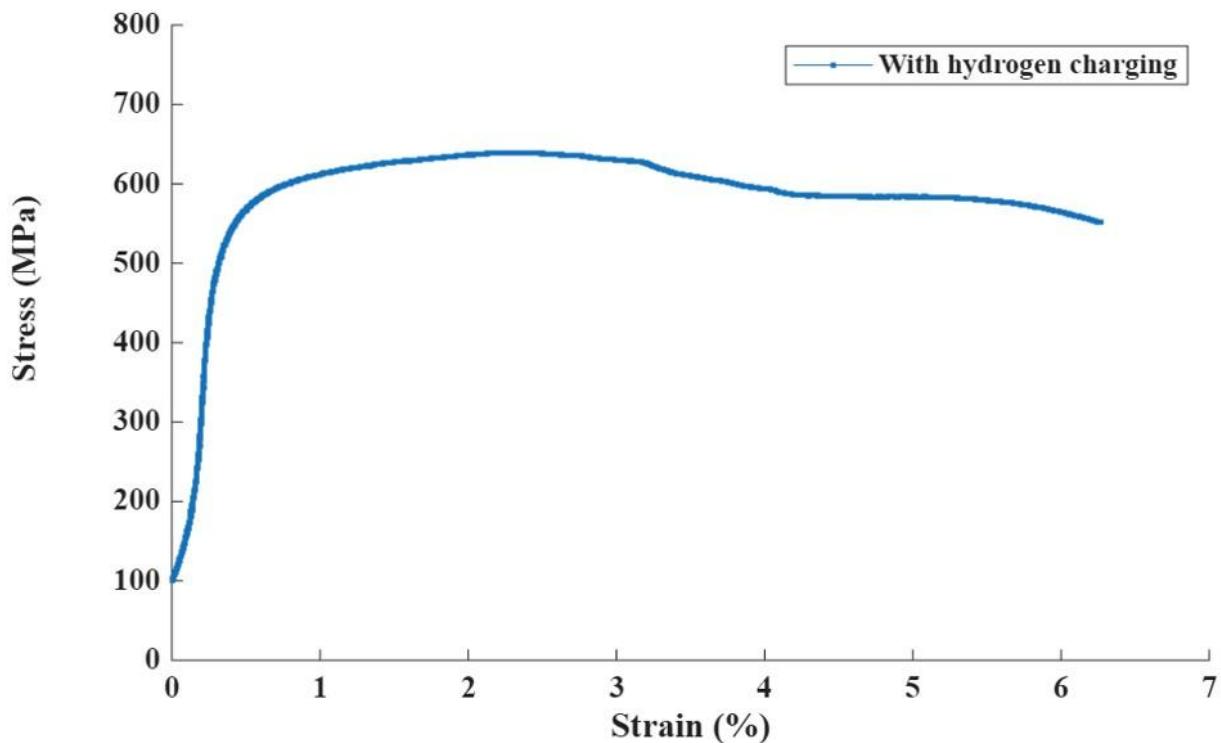
Figure 0.7: Stress-Strain Curve under Hydrogen Charging

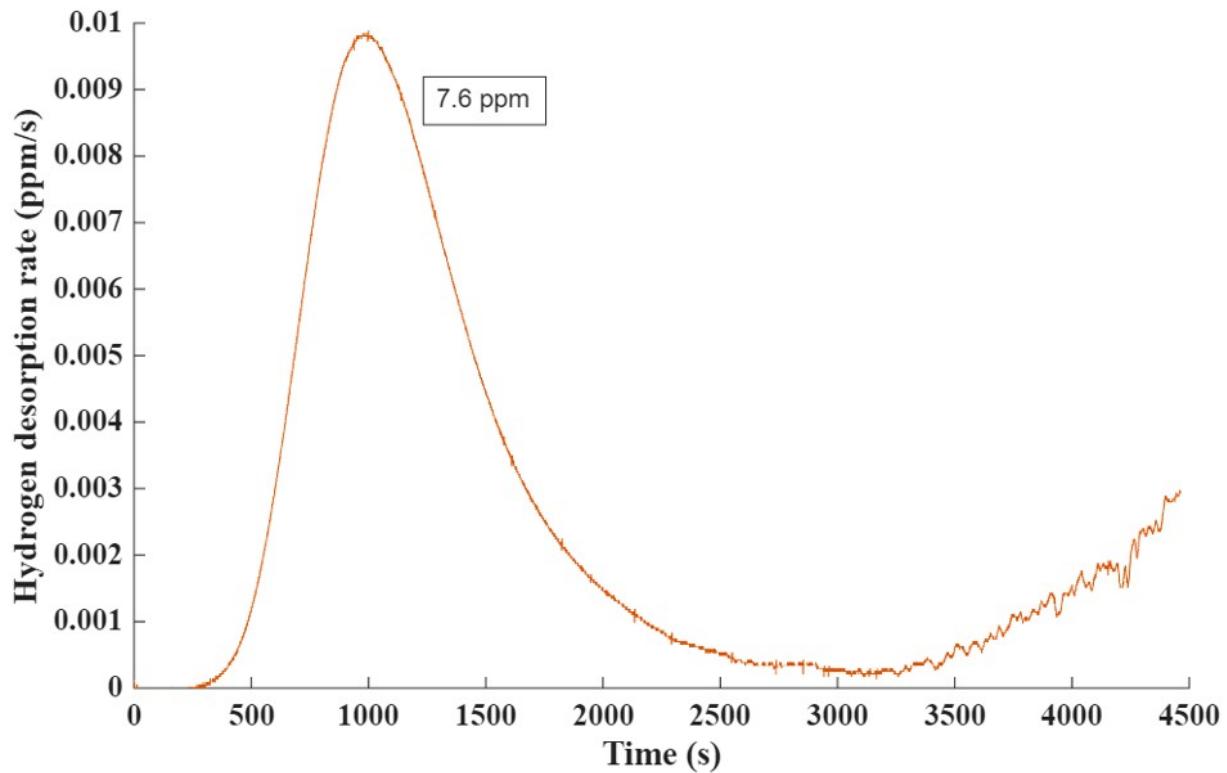
Figure 0.8: TDA desorption over Time

Peaks observed in the TDA curve indicate desorption of diffusible and trapped hydrogen.

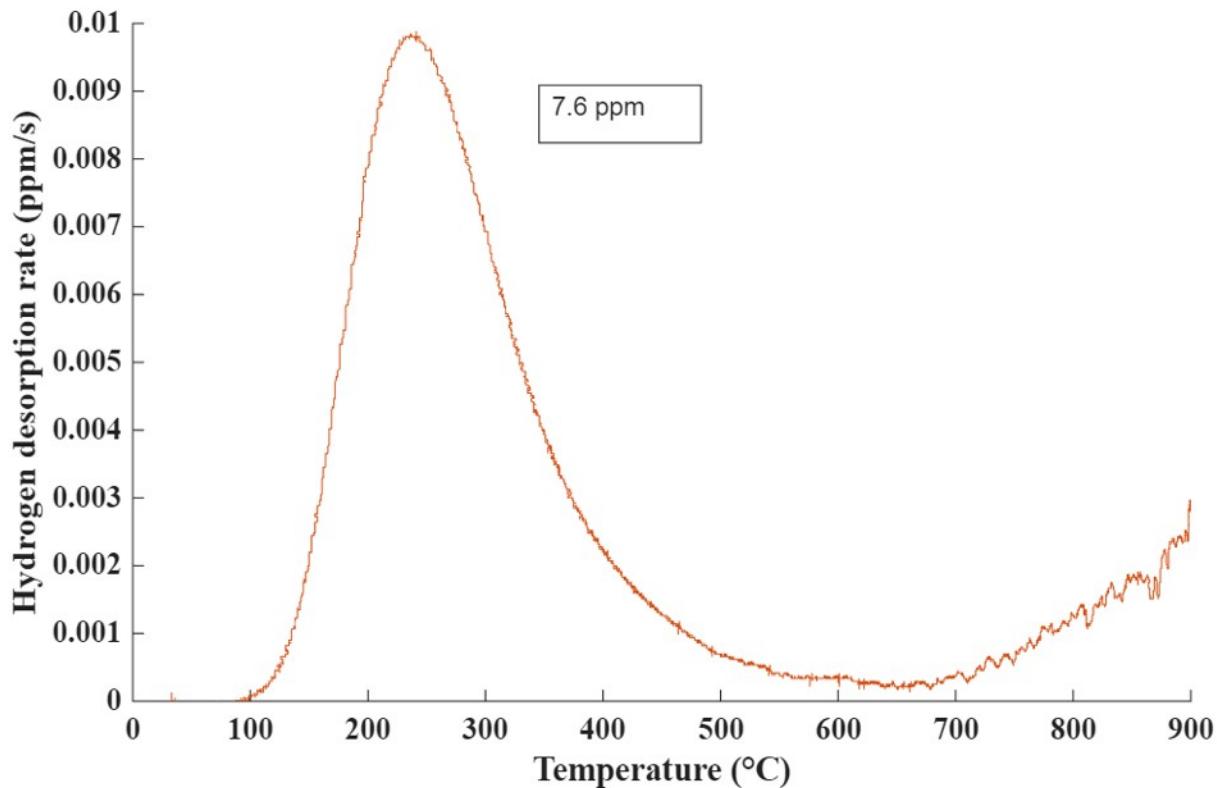
Figure 0.9: TDA desorption curve of DSS as temperature rises

Figure 3.8 illustrates the gradual emission of hydrogen during heating. At the beginning, there are weak traps, the later time indicated strong traps. This demonstrates that by determining the temperature, the steel can be heated to that point before being used, a process known as bake-out or hydrogen degassing. The steel will be less likely to fail when utilized in hydrogen rich environments because the heat pushes out the hydrogen that may develop cracks later in the material.

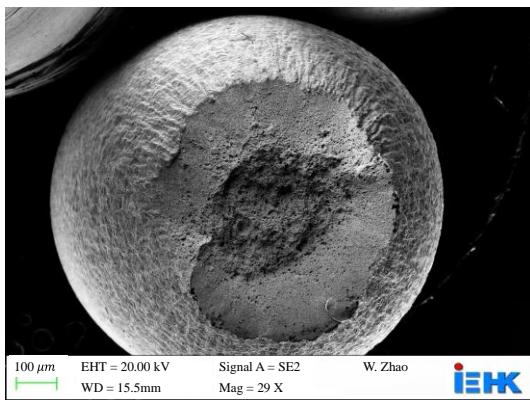
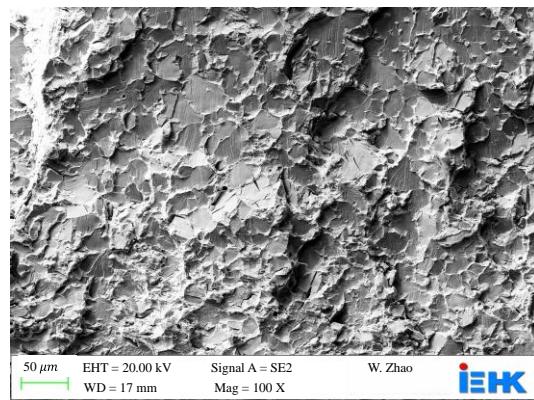
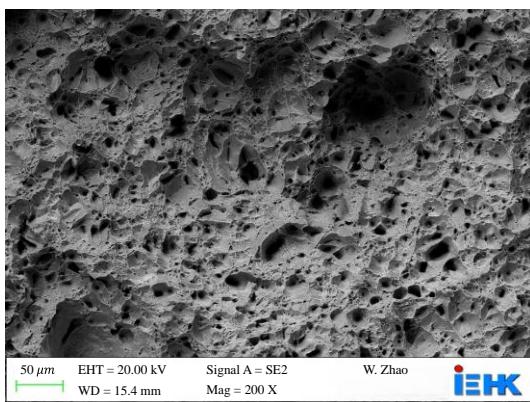
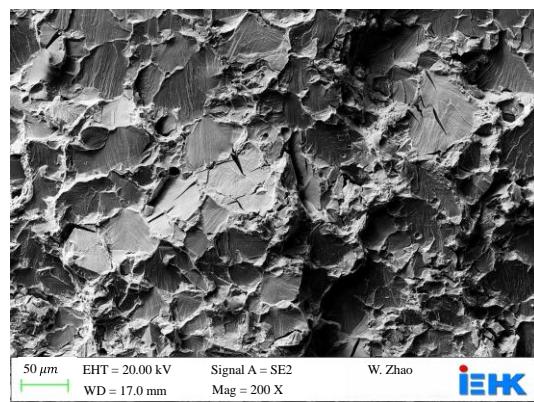
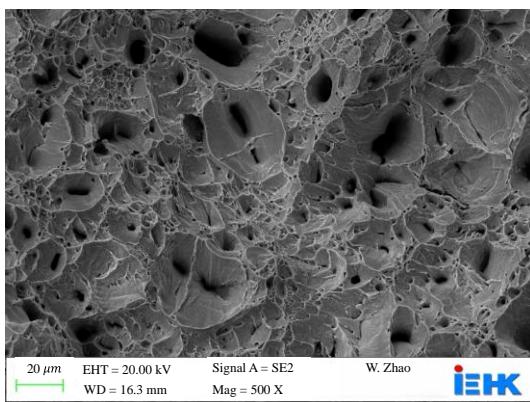
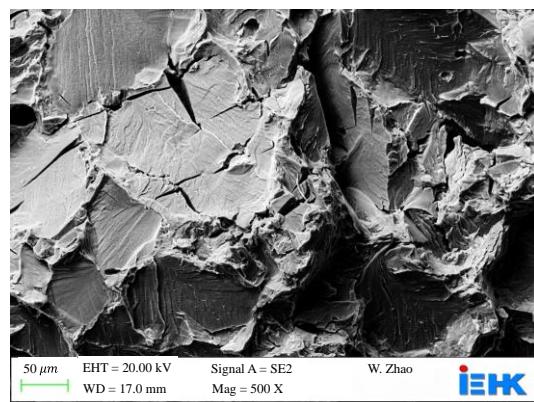
Fracture surface analysis was carried out using SEM, in order to understand the failure mechanisms under both air and hydrogen charged conditions. As shown in Figure 0.10, without hydrogen charging, SEM revealed ductile fracture features, including uniformly distributed dimples, indicative of microvoid coalescence typical of ductile tearing. Then under Hydrogen Charging, SEM shows brittle fracture features, such as the flat, shiny surfaces representing the cleavage facets; cracks running along the edges of grains representing the intergranular cracks and smaller cracks branching off from the main one which is the secondary cracks. All these indicates that the presence of hydrogen caused the material to shift from a tough, ductile way of breaking to a more sudden and brittle type of fracture.

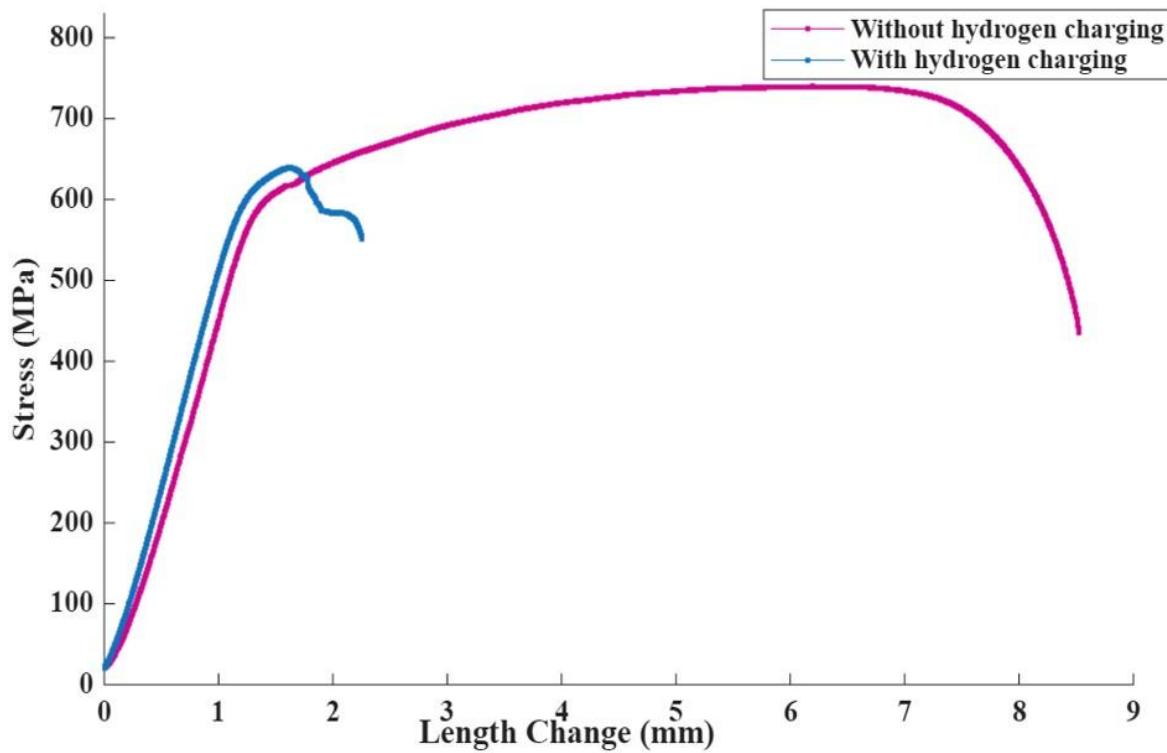
Figure 0.11: Combined stress-length change curves

The degradation in mechanical performance shows the hydrogen embrittlement vulnerability of DSS.

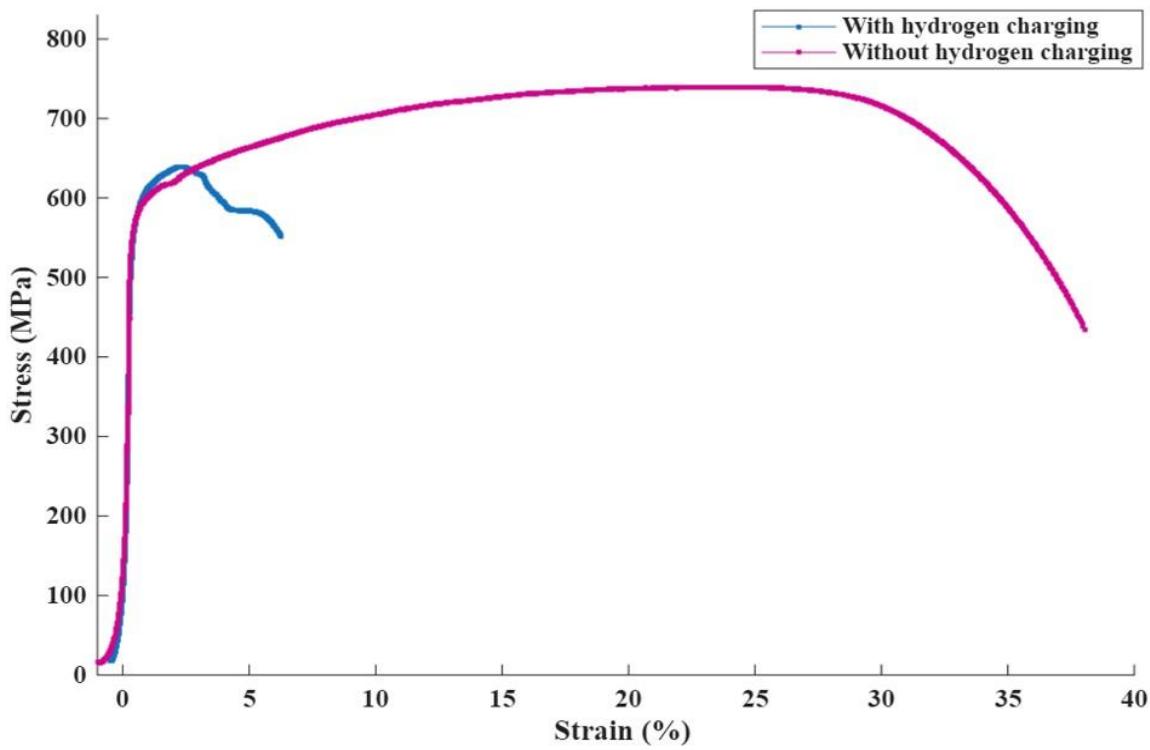
Figure 0.12: Combined stress-strain curves
